INVENTOR: Daniel BARICH, Timothy DONAHUE, Ade AUDIFFEREN
FOR: METHOD AND ARRANGEMENT FOR INSPECTION AND
REQUALIFICATION OF VEHICLES USED FOR TRANSPORTING
COMMODITIES AND/OR HAZARDOUS MATERIALS

**METHOD AND ARRANGEMENT FOR INSPECTION AND
REQUALIFICATION OF VEHICLES USED FOR TRANSPORTING
COMMODITIES AND/OR HAZARDOUS MATERIALS**

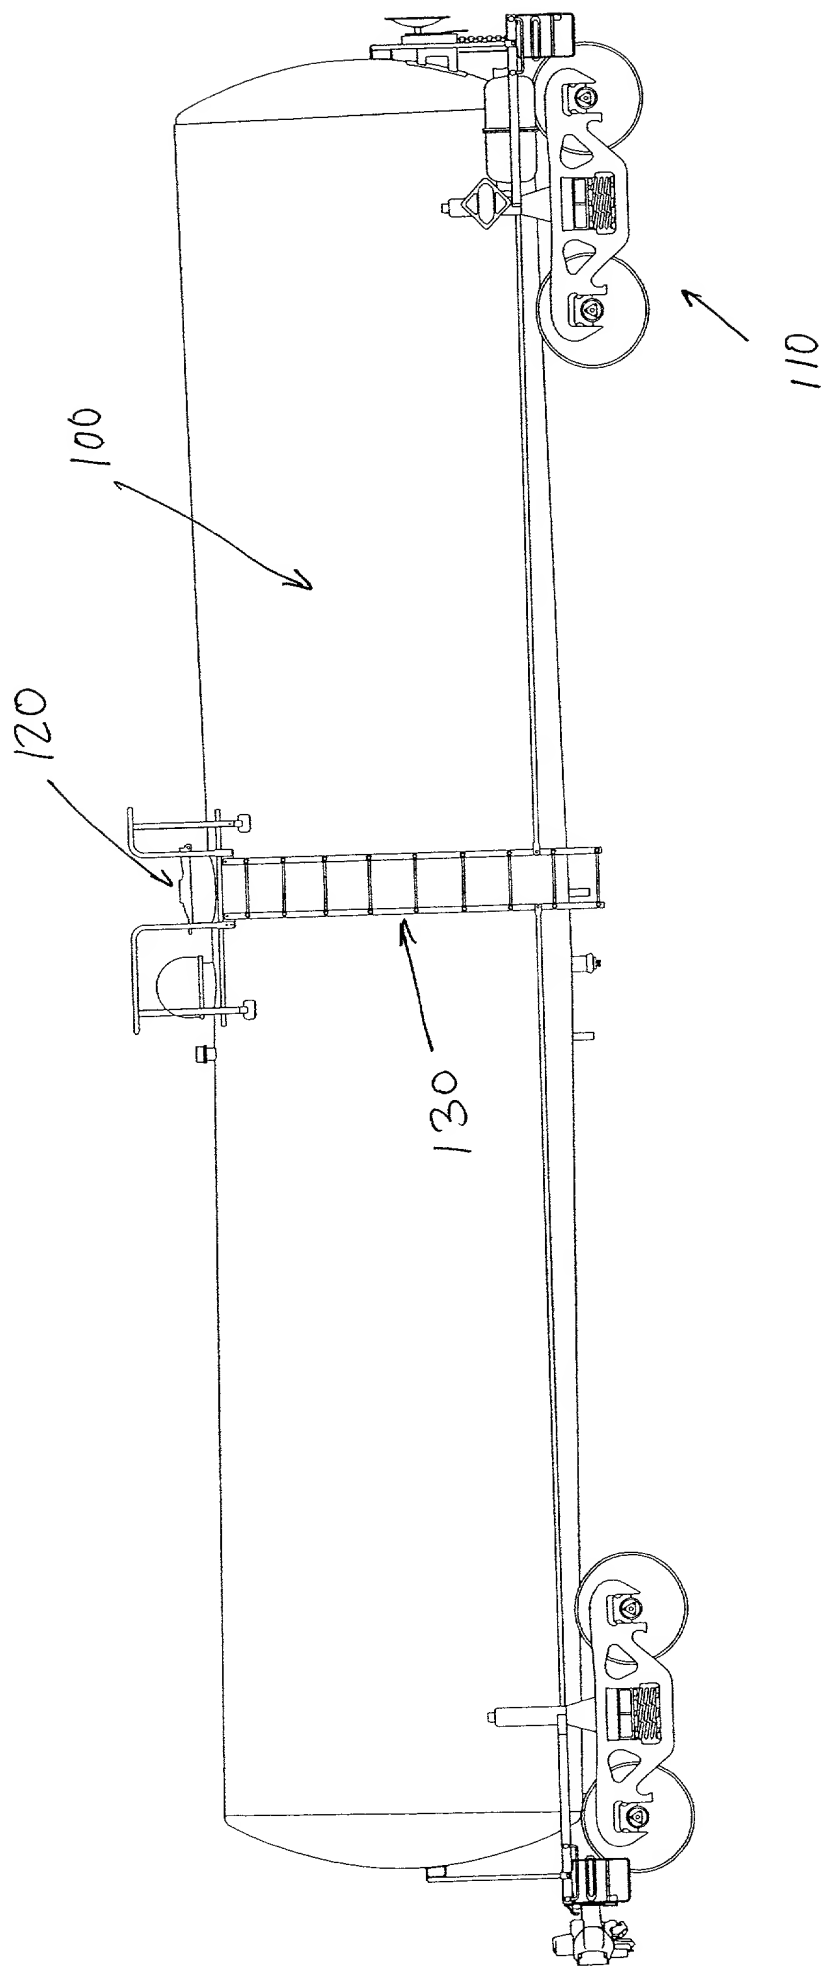
FIG. 1

5 Fig. 1 is a side view showing a typical tank car configuration;

Fig. 1 depicts a typical tank car which is subjected to examination and requalification according to the present invention. As shown, this vehicle is used to transport commodities and possesses a tank structure 100 with wheeled carriages 110
20 connected to the underside. It should be noted that, independent of the type of tank car which is involved, the tank per se is invariably a self-contained structure sufficiently rigid/strong to support not only its own weight but the weight of the cargo which is introduced into the tank. The understructure includes two or more wheeled carriage members or bogies 110 secured to the tank, such as by connectors or by the weight of the

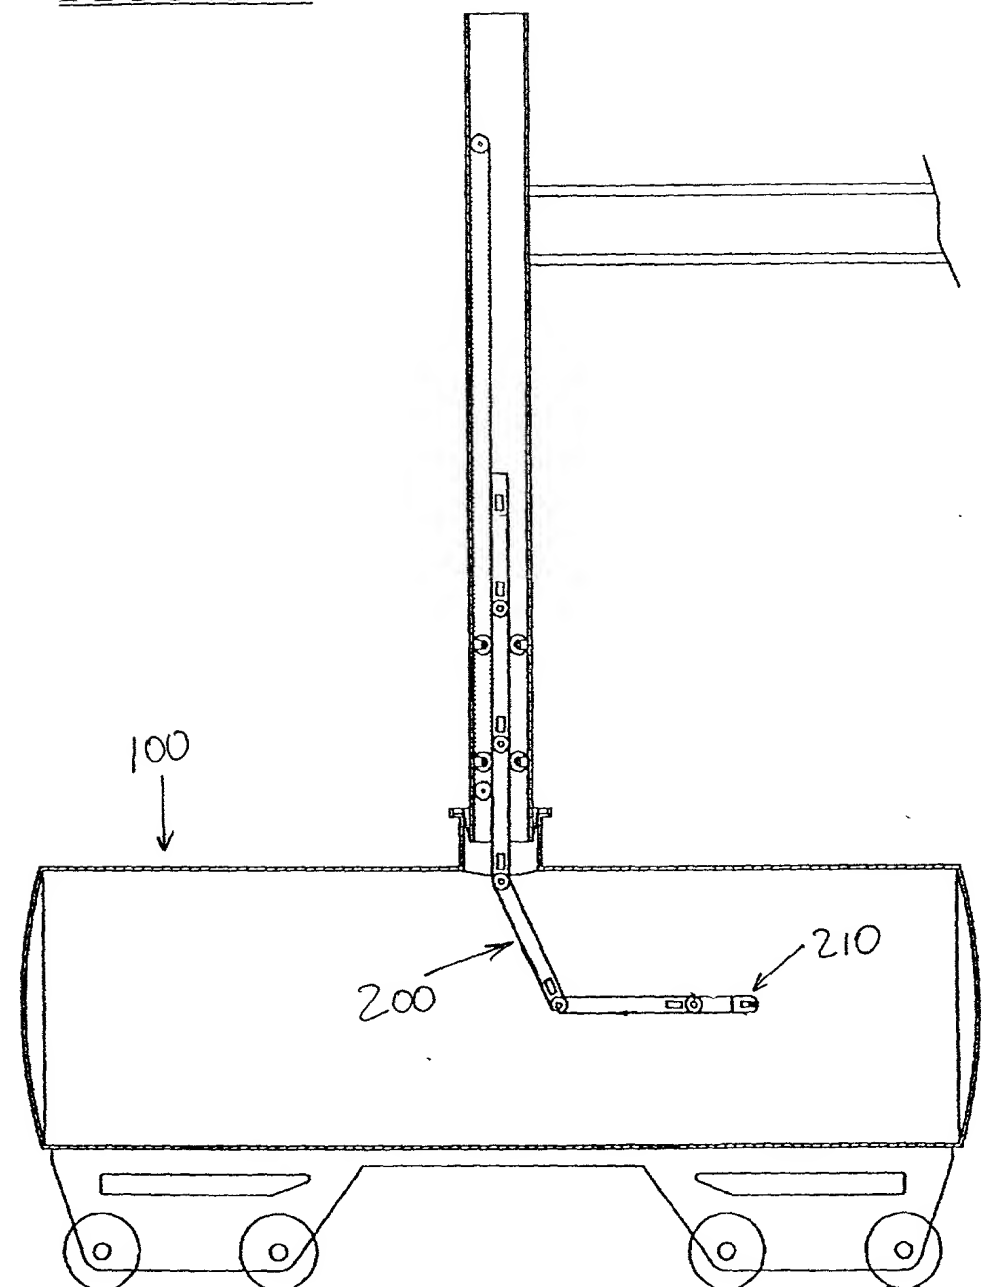
FIGURE 2

Fig. 2 is a schematic representation of a tank car which is being inspected robotically using an arrangement which could be used with the present invention in order to assist in inspecting/measuring the interior of a cylindrical vessel which forms a vital part of the tank car structure;

Fig. 2 depicts a tank car being inspected robotically via an arrangement provided in U.S. Patent No. 5,956,077 issued on September 21, 1999 to Qureshi et al. As shown, the tip of the snake-like probe 200 is provided with a sensor 210. Sensor 210 can, for the purposes of the present invention, take the form of an ultrasonic sensor or any other form of non-destructive sensing arrangement. Alternatively and/or in addition to the sensor, the tip can be provided with a camera and powerful illumination means for facilitating tank interior inspection. This type of arrangement has merit in the instances that the tank has not been cleaned out to the degree that it is safe for a person or persons to physically enter the tank and perform the required inspections, tests and data recordation. Non-limiting examples of sensor types and configurations compatible with the present invention are provided in United States Patent No. 5,256,966 issued on October 26, 1993; United States Patent No. 5,036,707 issued on August 6, 1991 to Paciej et al.; United States Patent No. 4,368,644 issued on January 18, 1983 to Wentzell et al.; United States Patent No. 4,658,649 issued on April 21, 1987; United States Patent No. 5,648,619 issued to Gustafsson et al. on July 15, 1997; United States Patent No. 4,490,833 issued to Inomata et al. on December 25, 1984; or United States Patent No. 5,619,423 issued on April 8, 1997 to Scrantz.

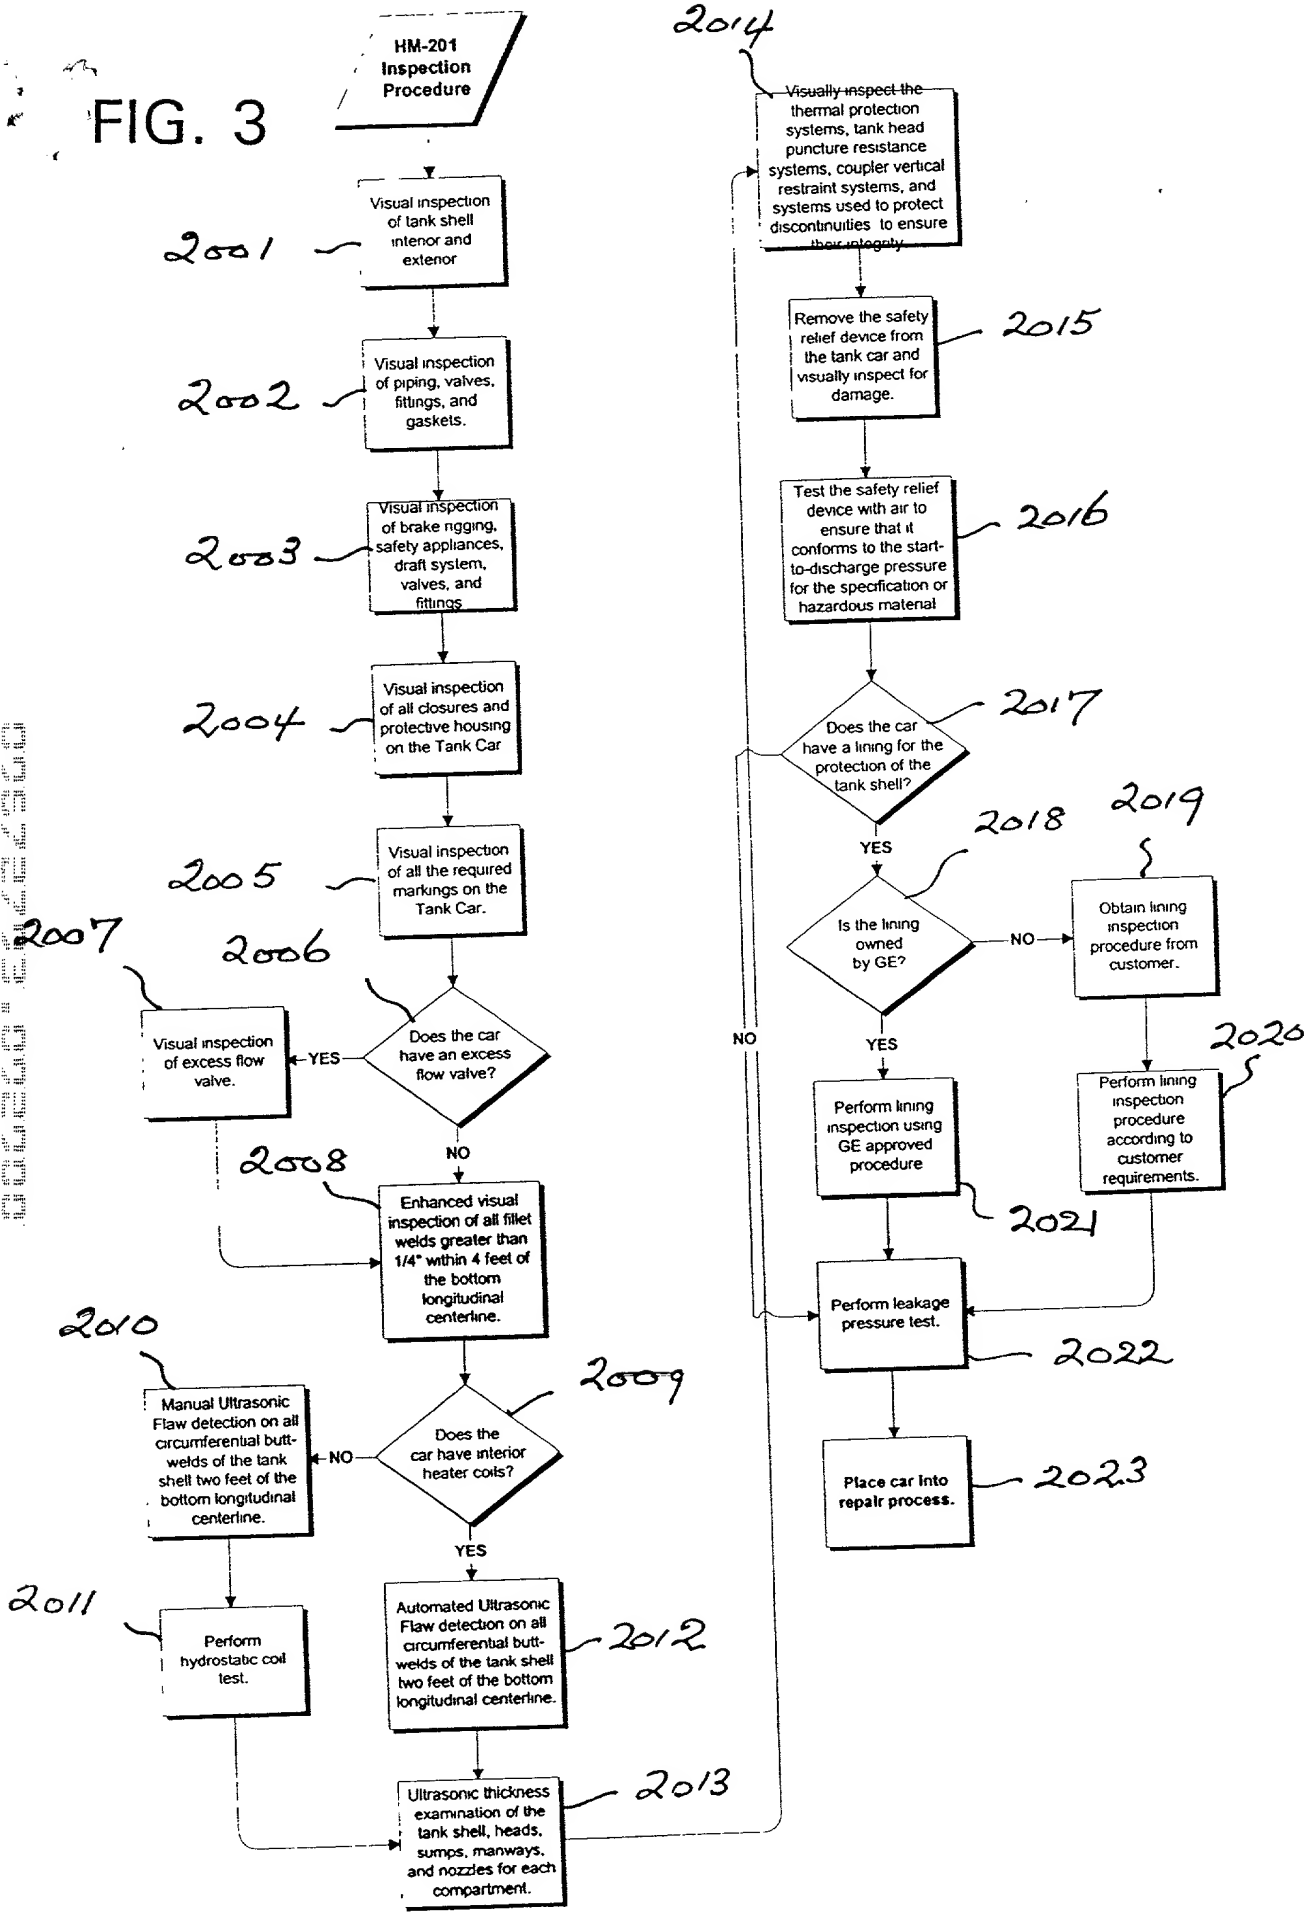
FIG. 3

10 Fig. 3 is a flow chart depicting the general procedure in accord with the present invention;

Test. The flow chart in Fig. 3 depicts the general flow of the process in accord with the invention.

Subsequent to this determination, ultrasonic flaw detection on all circumferential butt-welds of the tank shell which are two feet from the bottom of the longitudinal center line of the car, is carried out in steps 2010 or 2012. As depicted in the flowchart of Figure 3, manual ultrasonic welding is performed in the event the car has interior heating coils and automatic ultrasonic welding is performed in the event the car does not have interior heating coils. Although not indicated, manual ultrasonic welding may also be performed when the tank car does not have interior heating coils. After ensuring of the ultrasonic tester in a manner known to those skilled in the art, the weld and surrounding areas are cleaned if necessary to remove, for example, residual commodity, weld splatter, rust scale, rust bloom, and surface pitting in excess of about 0.030", to permit accurate inspection of the circumferential butt-welds, shown in Figure 13A. It is preferred that, at a minimum, the circumferential butt-welds within approximately two feet of each side of the bottom longitudinal centerline are inspected using an ultrasonic flaw detecting device.

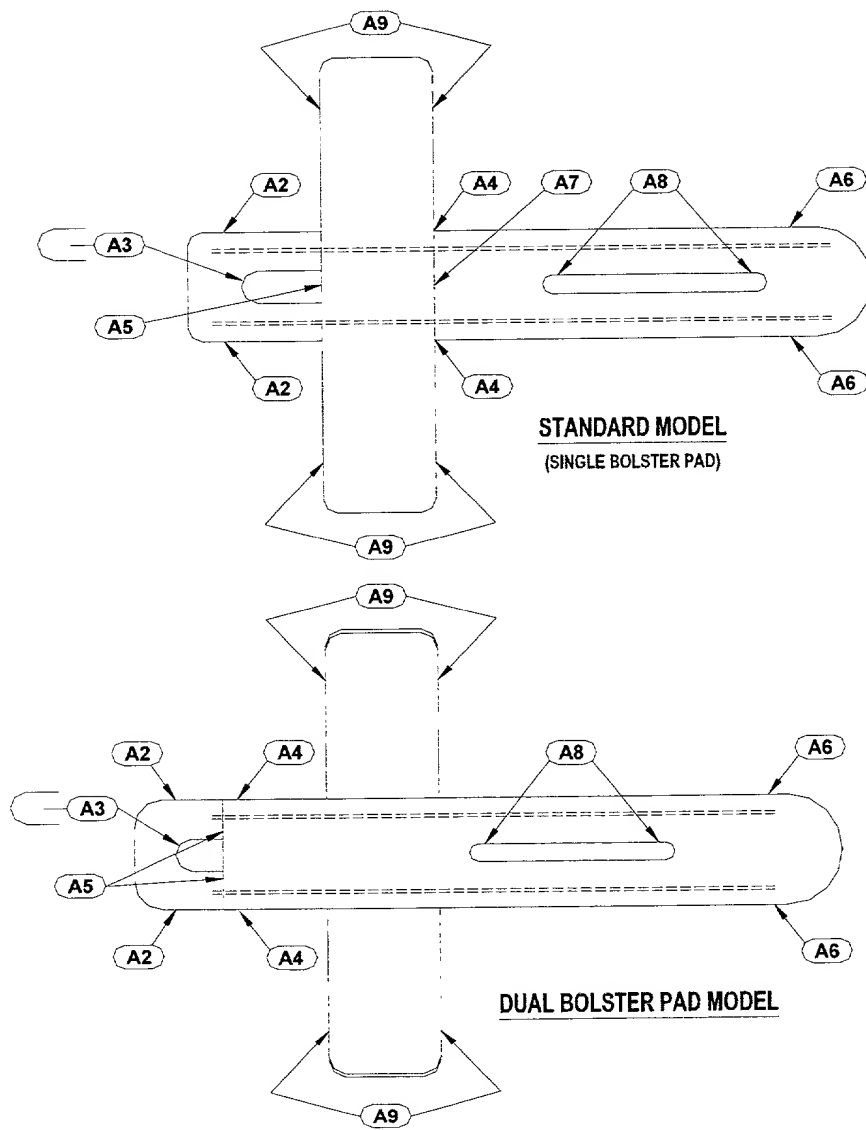
Figure 7A

20 Figs. 7A-7H depict an aspect of the enhanced inspection of tank car welds as they relate to Evans Railcar (EVA) and WBR (original EVA design modified to include head brace) stub sill configurations.

Figures 7A-7H depict another preferred aspect of the invention wherein the detailed weld inspection in accord with step 2008 particularly relates to welds on tank cars built using the Evans Railcar (EVA) and WBR (original EVA design modified to include head brace) stub sill configurations. In most respects, the weld locations, relation to

regulatory requirements, and inspection requirements are as set forth with respect to Figures 5A-5H, above, and the related discussion. Reference to Figures 7A-7H, which use the same reference numerals as Figures 5A-5H are illustrative of the differences between the tank car designs.

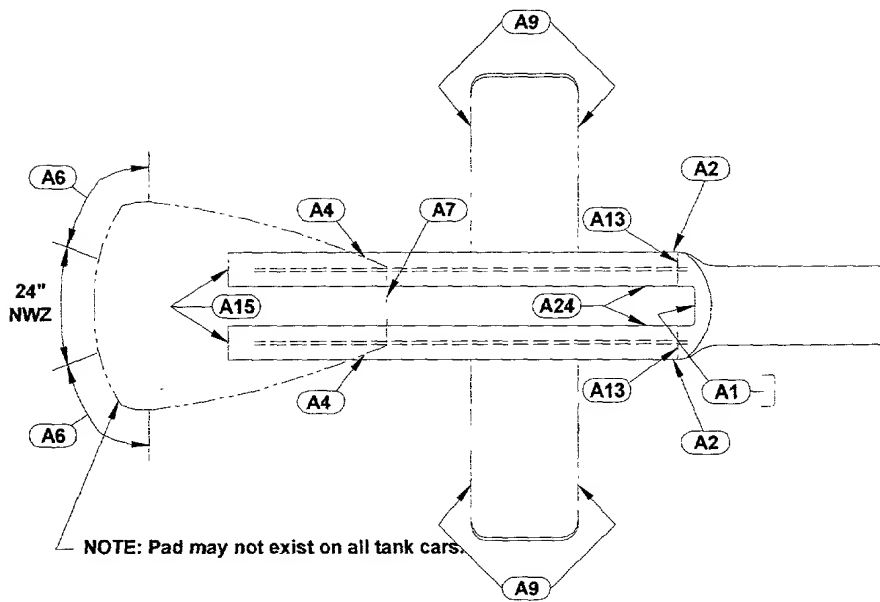
Figure 8A

5 Figures 8A-8H depict yet another preferred aspect of the invention wherein the detailed weld inspection in accord with step 2008 particularly relates to welds on tank cars built using ABC and JKL stub sill designs, such as those built by North American Car (NAC), AMF Beaird (AMF), Davie Shipbuilding Ltd. (DSL), and Hawker Siddeley Ltd. (HST). In some respects, the weld locations, relation to regulatory requirements, and
10 inspection requirements are as set forth with respect to Figures 5A-5H, above, and the related discussion with exception of notable differences provided below with reference to Figures 8A-8H.

Figs. 8A-8H depict yet another aspect of the invention wherein the detailed weld inspection relates to welds on tank cars built using ABC and JKL stub sill designs, such as

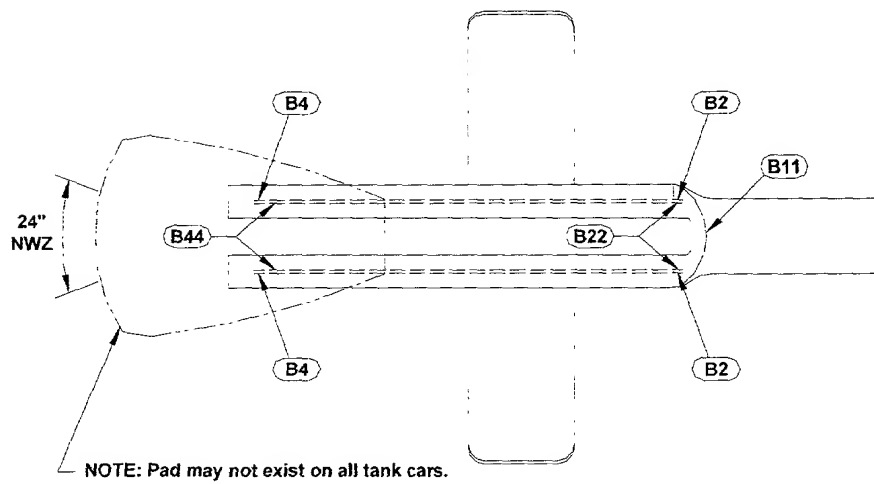
Figure 8B

As shown in Figure 8B, weld location B2 meets 88.B.2 requirements and shows outboard termination of longitudinal weld (outside of sill) at the A and B end left and right positions. The last 6" of the weld to termination is inspected. Weld location B4 meets

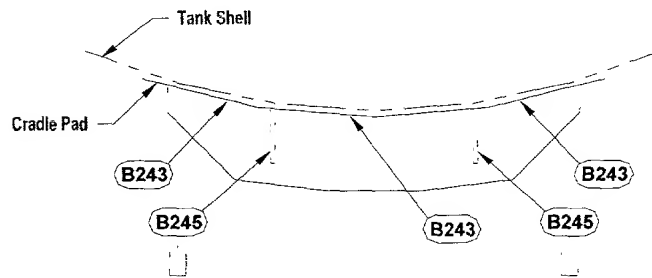
NOTE: Inboard of bolster at end of cradle pad, looking outboard.

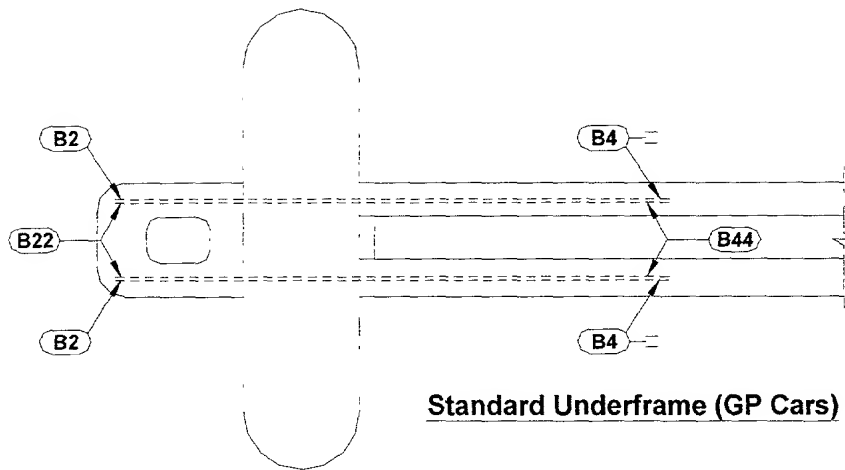
Standard Underframe (GP Cars)

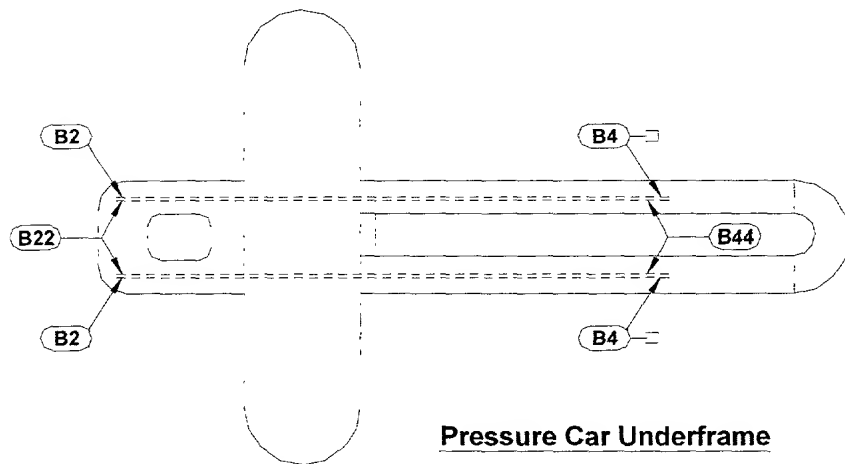
Pressure Car Underframe

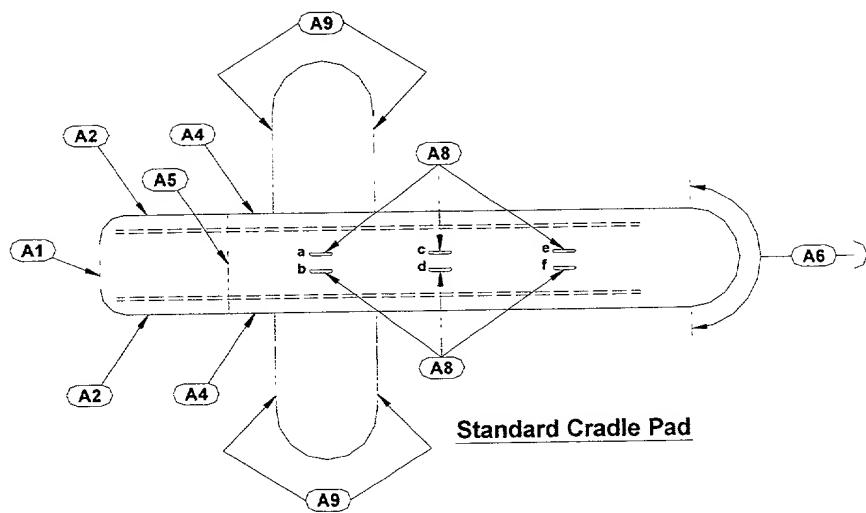
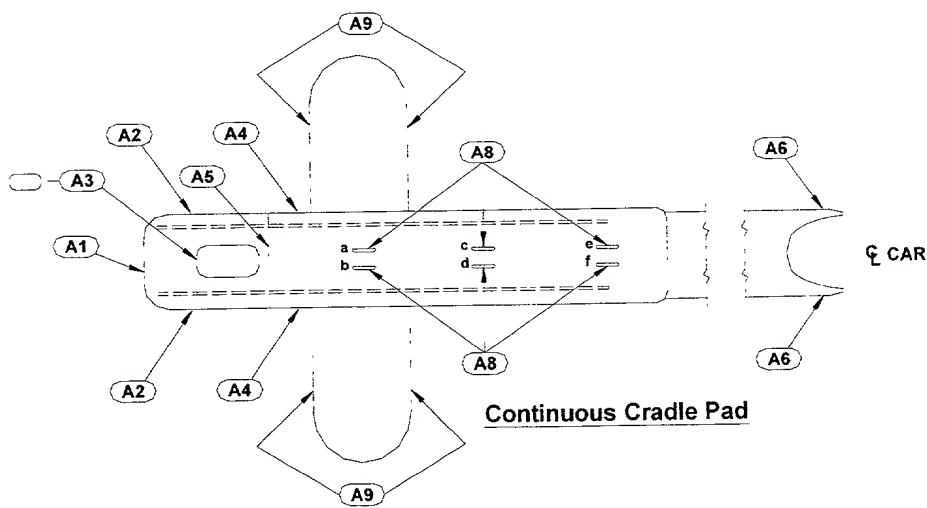
FIGURE 12A

Standard Cradle Pad

Continuous Cradle Pad

Figure 12A shows various pad-to-tank weld locations. Weld location A1 satisfies inspection requirements under HM-201, SSIP, and Rule 88.B.2. It depicts a front sill pad-to-tank transverse weld located at the A and B ends and is inspected along a full length of the weld, including a portion around the corner of the pad. Weld location A2 meets HM-201, SSIP, and 88.B.2 requirements and depicts front sill pad longitudinal welds located at the A and B end right and left portions. A full length of the weld to termination at the bolster pad is inspected. Weld A3 meets HM-201 requirements and shows fillet welds in the front sill pad-to-tank cutout located at the A and B ends. A full length of the weld is

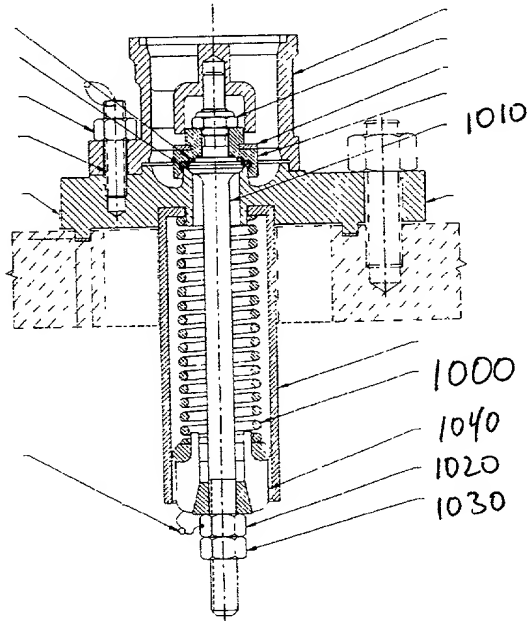
FIGURE 15C

TYPICAL TOP MOUNTED SAFETY RELIEF VALVE

Midland A-1435 Design

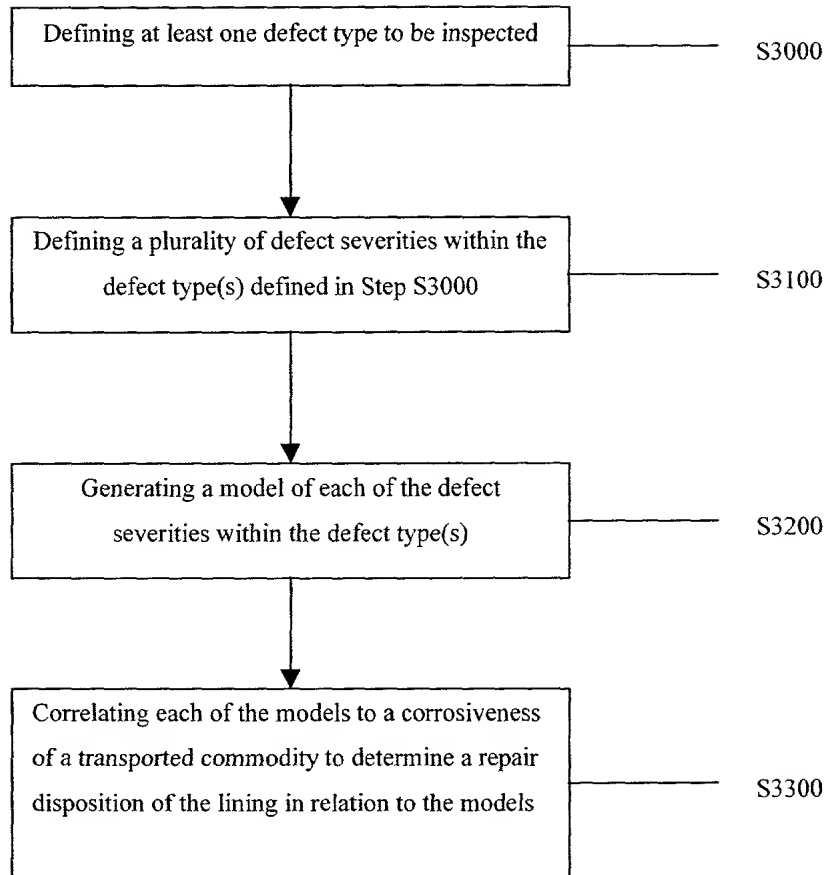
Figure 16

20 Fig. 16 is a flowchart illustrating a method of standardizing a test procedure in accord with the invention.

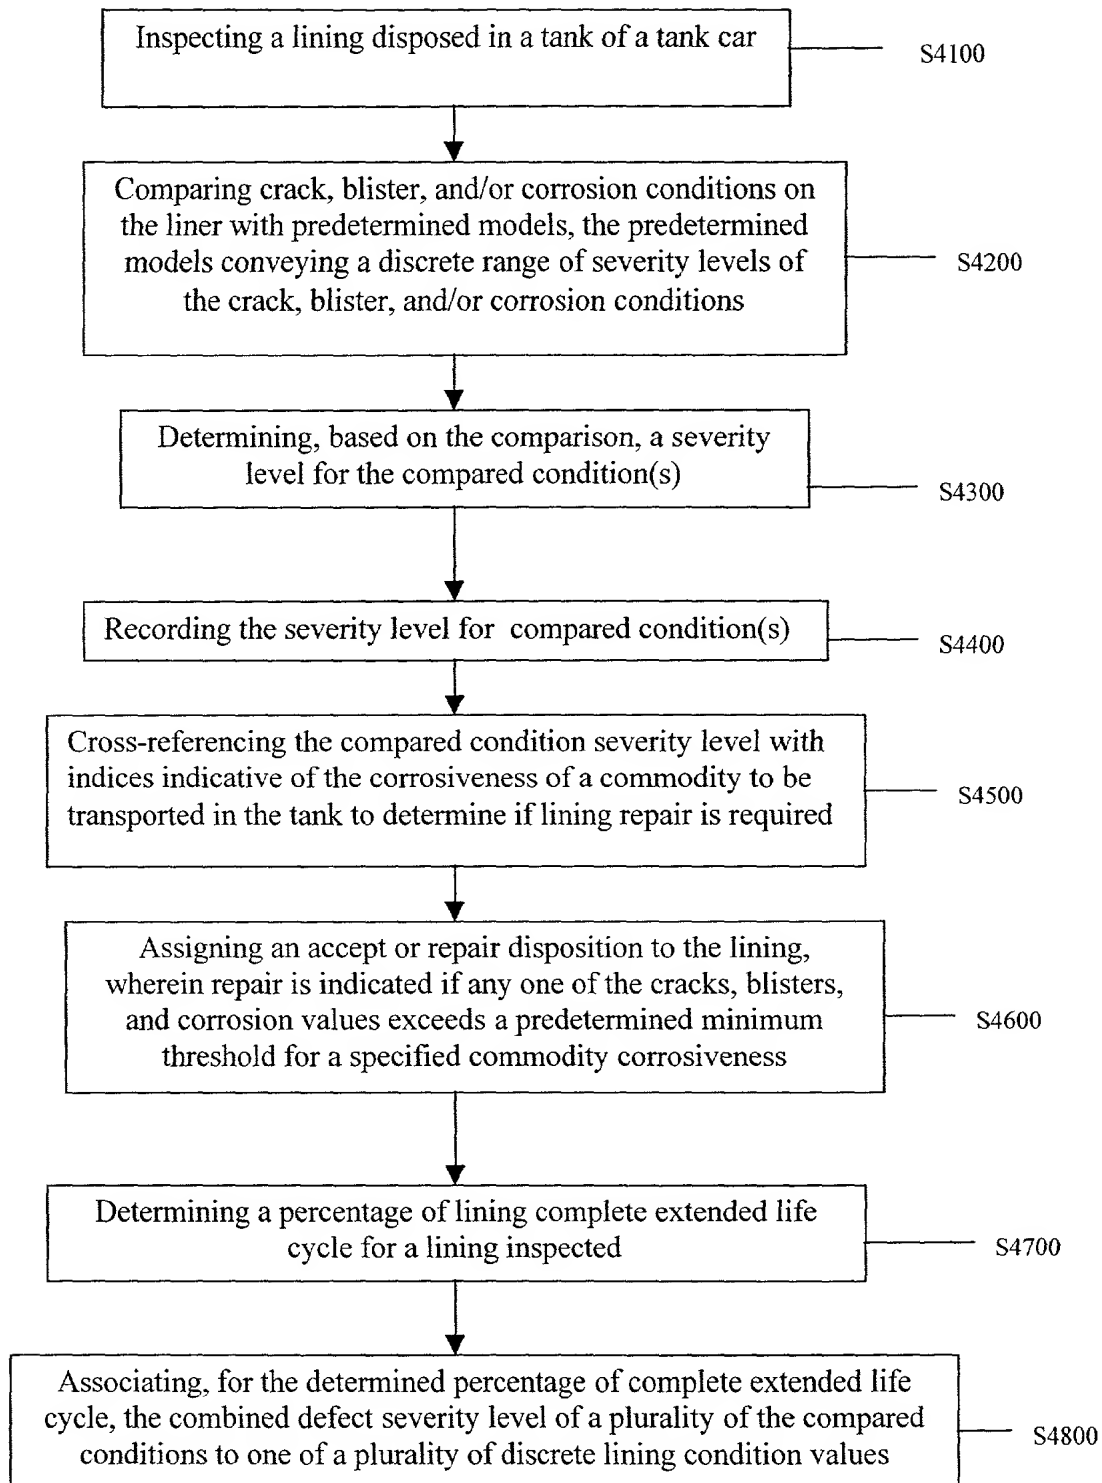
Figure 17

Fig. 17 is a flowchart illustrating a method of inspection in accord with the invention.

The test procedure for inspecting a vehicle adapted to transport commodities in accord with the invention is depicted in FIG. 17. In step 4100, the tank car lining is inspected. Step 4100 may include inspection for staining or discoloration of the lining or coated surface. All surfaces are visually inspected for signs of contrast in color. If such discoloration is observed, the inspector must use a cleaning solution such as a solution of 1% hydrochloric acid diluted in water in combination with a light colored, preferably white, cloth to determine whether or not the cloth is itself discolored by the stain.

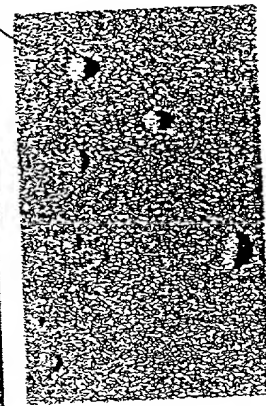
2.5%
BLISTERS
COVER
TOTAL AREA
FEW

Inspect the lining surface for evidence of blistering. Match the visual standards with the actual condition of the lining to determine the size and frequency of the blistering.

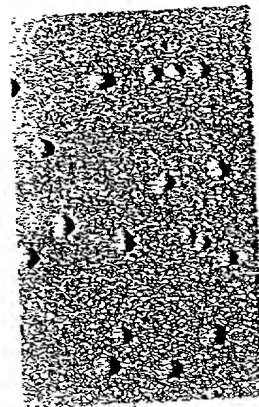
15%
BLISTERS
COVER
TOTAL AREA
MEDIUM

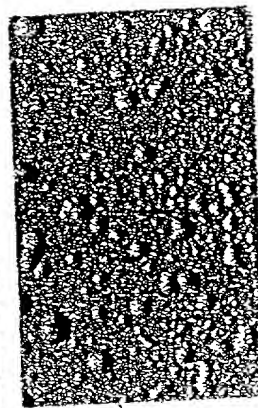
45%
BLISTERS
COVER
TOTAL AREA
MEDIUM DENSE

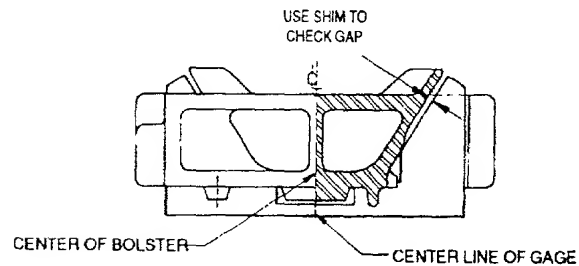
GAGE IN WORN BOLSTER POCKET

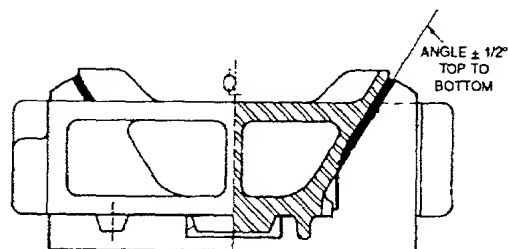
GAGE IN REPAIRED BOLSTER POCKET

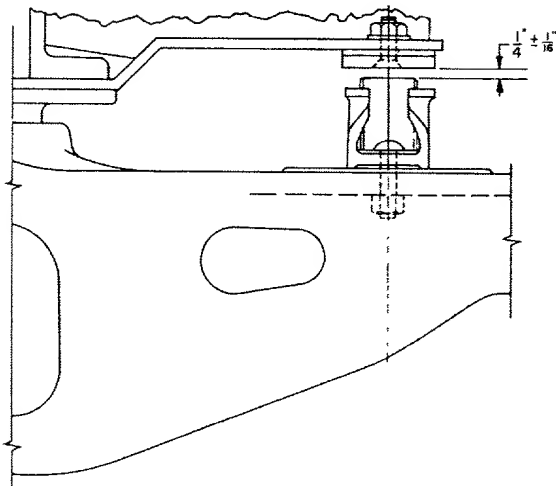
Figure 26a

Figs. 26a-b illustrate a body center plate and side bearing visual inspection
method.

Further in accord with Rule 88.B.2, the body center plate and side bearings are inspected. For roller side bearings, illustrated in Figure 26a, the side bearing clearance must be measured prior to removing the trucks from the car. A step gage or other suitable gage or instrument is used to measure the gap between the top of the roller and the side bearing. The gap should be between $3/16$ " and $5/16$ " as shown in Figure 26a. It is acceptable to average two side bearings diagonally at each end of the car. For constant contact models, as shown in Figure 26b, the trucks must first be removed and then the rockers removed from the side bearing cage. The height between the bottom of the roller cage and the side bearing is then measured and it should be between 5" and $5\frac{1}{8}$ ", as shown in Figure 26b. It is acceptable to average two side bearings diagonally at each end of the car. Following the above measurements, the trucks and rockers, as applicable, are replaced. The side bearings are visually inspected for cracked, broken, or missing portions and for worn or bent portions exceeding $1/8$ ". The side bearings are checked to ensure they are the correct side bearing for the particular car and the side body bearing is inspected for wear to determine if the minimum thickness at the centerline of the fastener is below the minimum acceptable limit of $5/8$ " (or $3/8$ " for cars built prior to 1981 with flat bearings).
